July 24, 2007

**Re: GE-Pittsfield/Housatonic River Site
Groundwater Management Area 3 (GEC330)
Addendum to Supplemental Soil Gas Migration Assessment Report and Sampling Plan**

GENERAL ELECTRIC COMPANY
PITTSFIELD, MASSACHUSETTS
**ADDENDUM TO SUPPLEMENTAL SOIL GAS MIGRATION
ASSESSMENT REPORT AND SAMPLING PLAN**

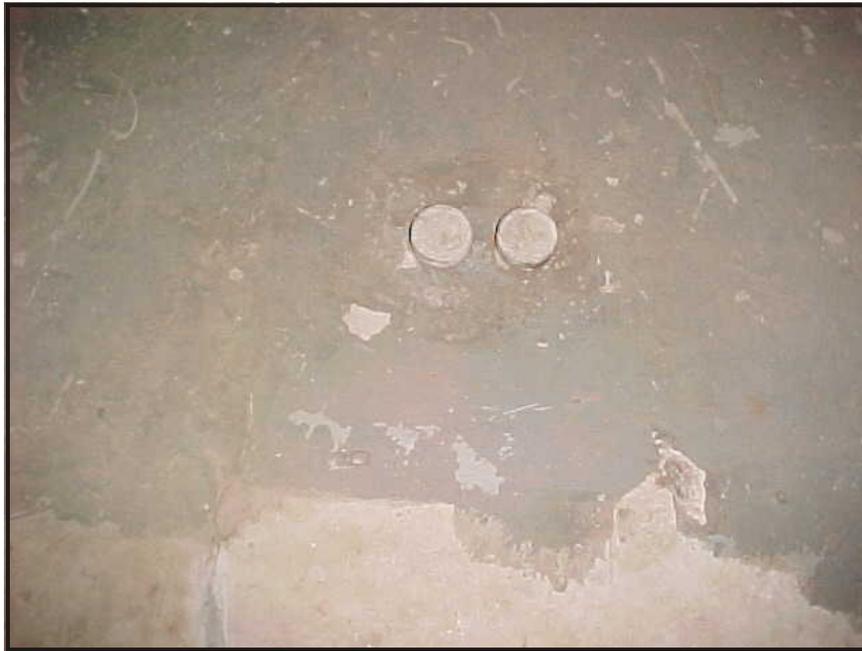
Items (11), (13), (14), and (15) were determined to be penetrations that may or did extend to the underlying soil. These items were addressed during the assessment by sealing each penetration with concrete grout. These consisted of conduit holes, superficial cracks, and cracks in floor seals around piping. Attachment A-1 provides photographic documentation of these activities.

(11) Photo of conduit holes sealed with concrete grout in the mechanical room at the south end of the building.

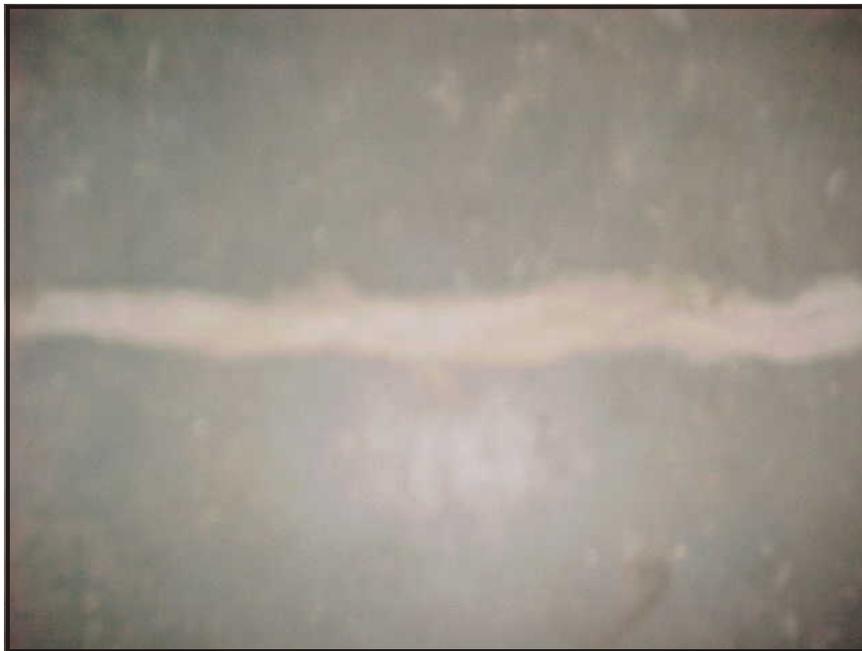
(13) Photo of a superficial crack sealed with concrete grout in the floor in the mechanical room at the south end of the building.

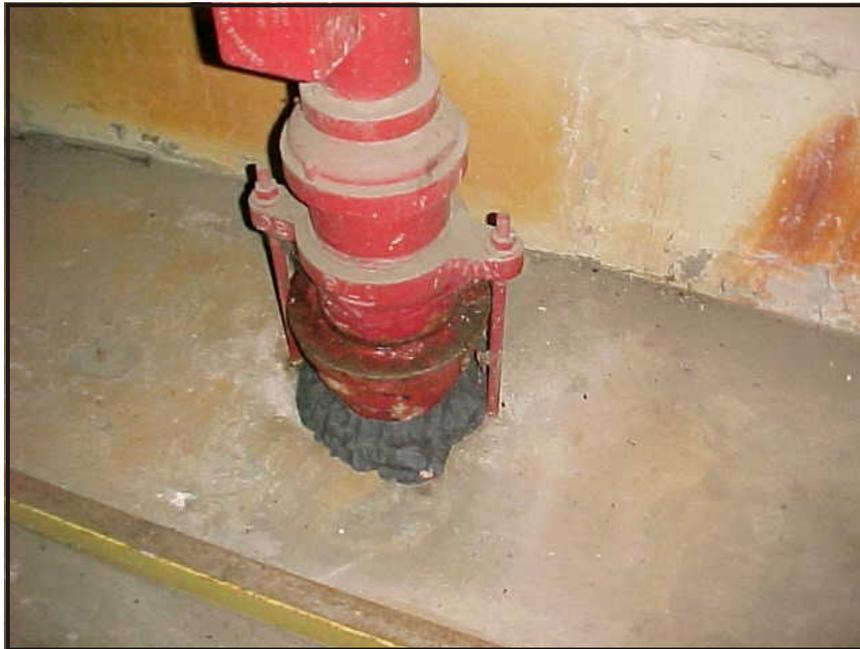
(14) Photo of fire riser in the high bay storage area in the northwest corner of the building that has been sealed with concrete grout.

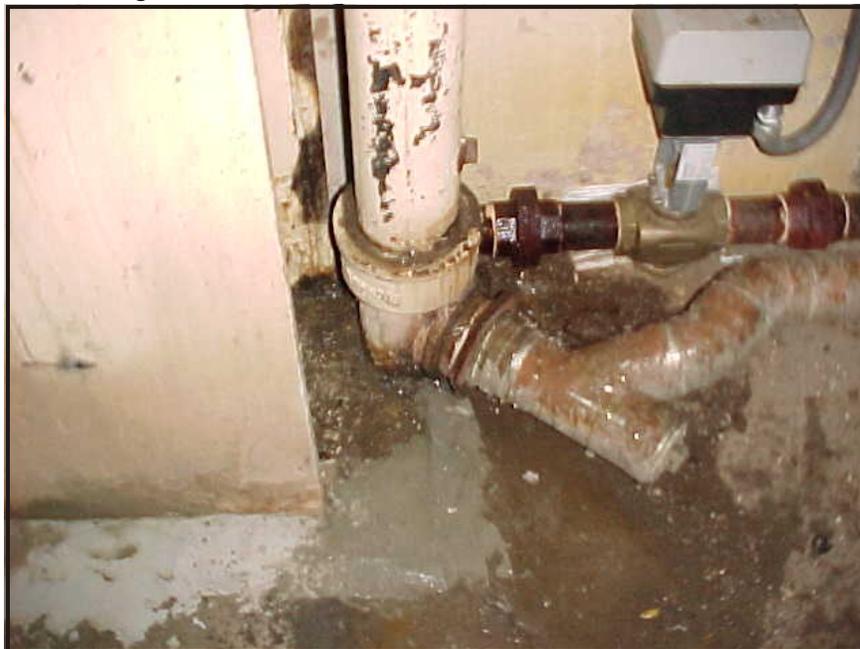
(15) Photo of roof drain in the high bay storage area in the northwest corner of the building that has been sealed with concrete grout.

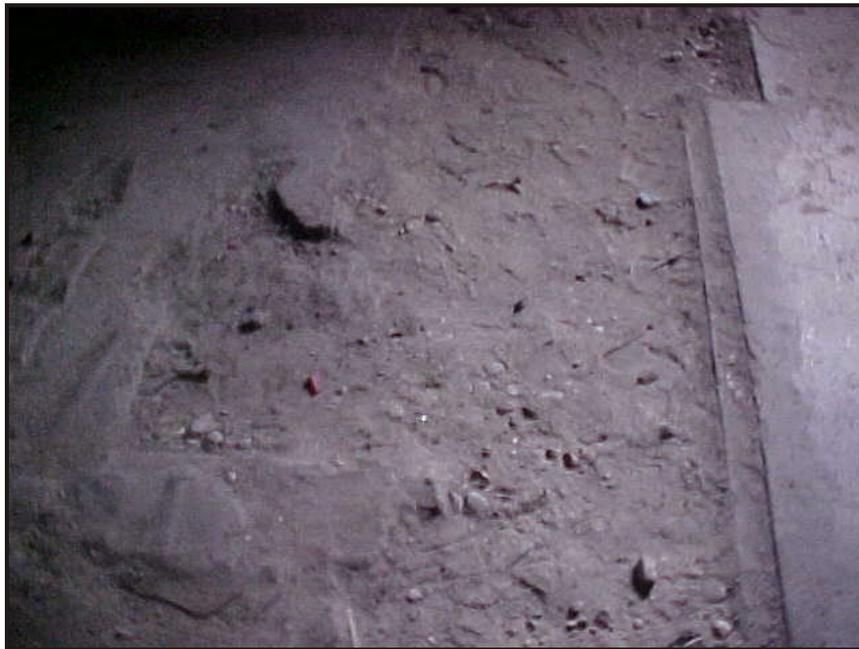
Items (19), (20), (21), (24) and (25) were determined to be penetrations that extend or may extend to the underlying soil, but were unable to be addressed or sealed during the available timeframe. These items included an open gravel floor area, two open pump pits, an open pipe chase, and a fire drain line at the unoccupied, northeast end of Building 51. Attachment A-2 provides photographic documentation of these potential pathways.

(19) Photo of representative open gravel floor area in the old boiler room at the northeast end of the building

GE believes that each of the above-listed penetrations that could not be addressed within the available timeframe can likely be sealed with concrete and/or concrete grout. GE will make an effort to seal those penetrations shortly. If any of those penetrations cannot be sealed, GE will submit a follow-up proposal to conduct soil gas sampling in the vicinity of those locations in accordance with Condition 2 of EPA's June 25, 2007 letter.

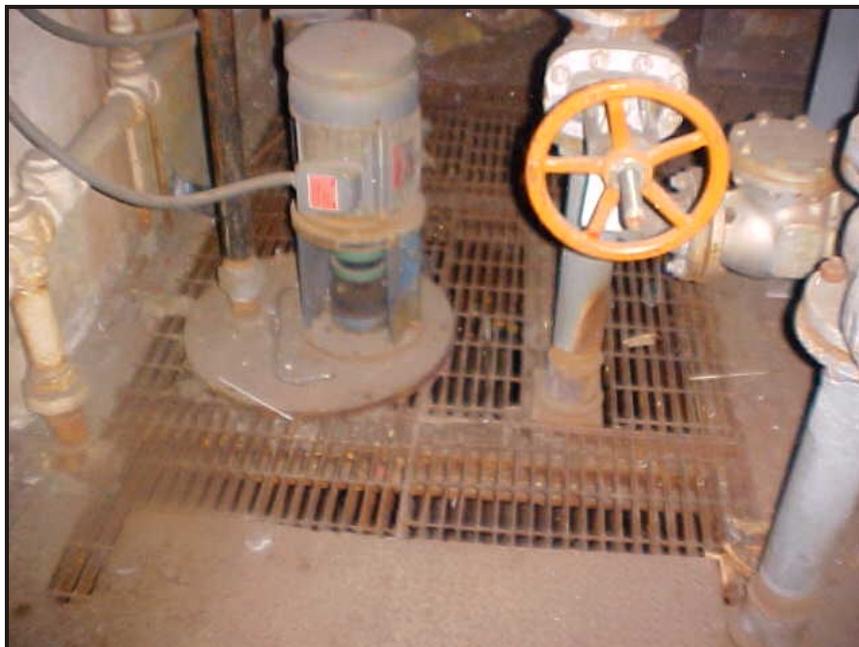
(20) Photo of a pump pit located below a steel grating area in the old boiler room at the northeast end of the building

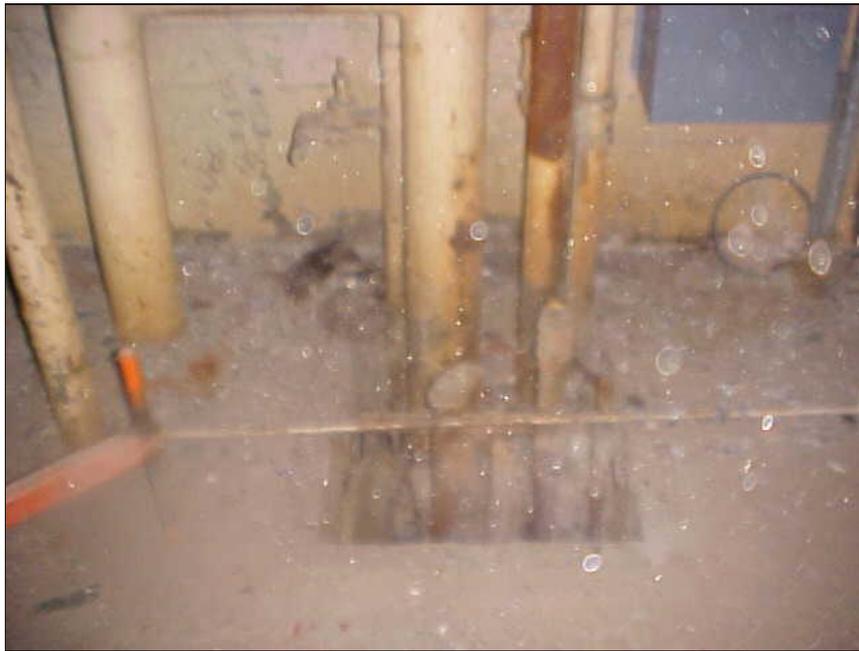
(21) Photo of an open pipe chase in the old boiler room at the northeast end of the building

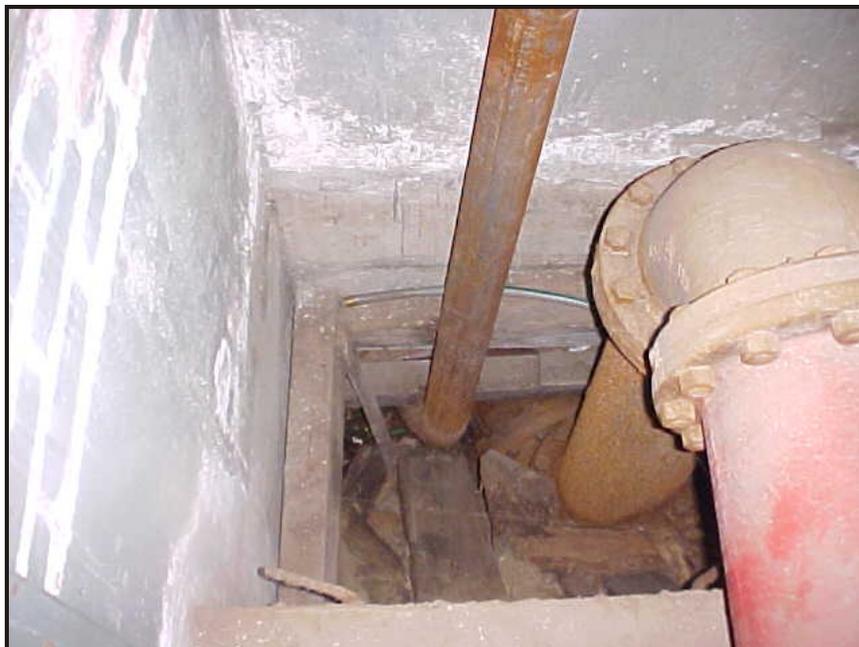
(24) Photo of a fire pump pit located just off the compressor room at the northeast corner of the building

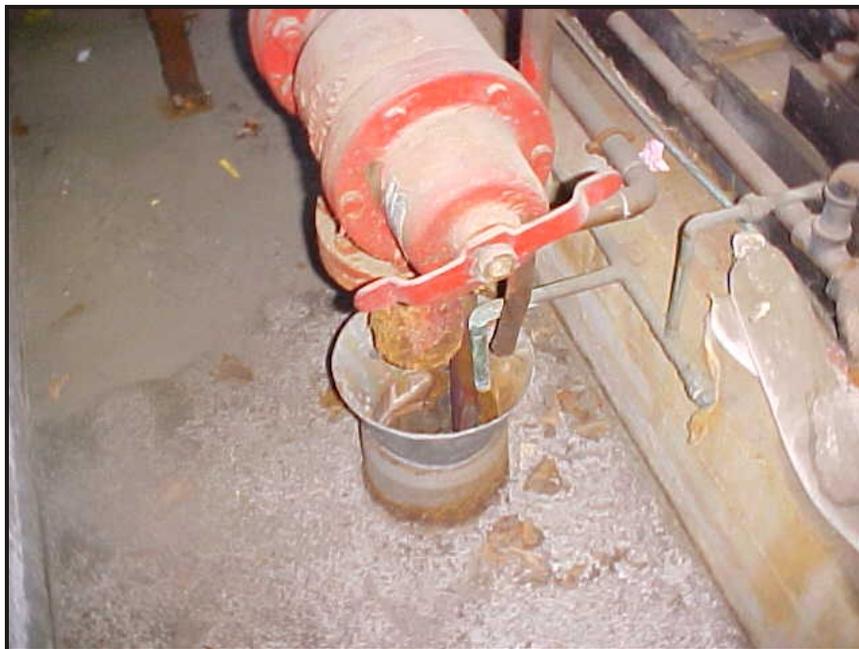
(25) Photo of a fire line drain in the fire pump room just off of the compressor room at the northeast corner of the building

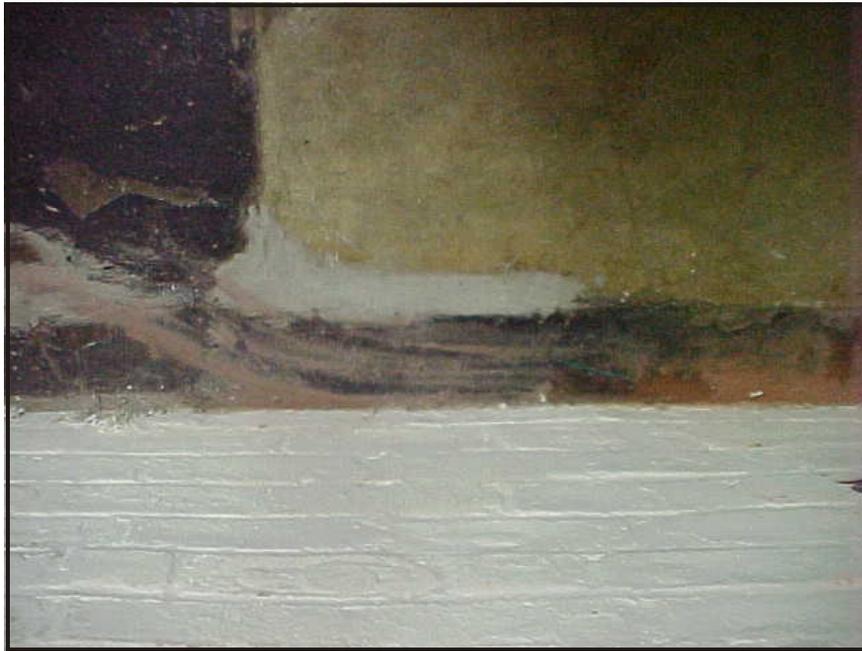
Items (4), (16), (17), (19), (20), and (25) were determined to be penetrations that may or did extend to the underlying soil. Items (4), (16), (17), (19), and (20) were addressed during the assessment by sealing each penetration with concrete grout. These consisted of conduit holes and superficial cracks. Item 25 (two steam pipes extending through a steel grate) was addressed by cutting the pipes below the steel grate and installing a new, fitted steel grate to seal over the pit below. Attachment B provides photographic documentation of these activities.

(4) Photo of a crack in the concrete floor on the north wall of the server room that appeared to be superficial with a depth of 2 - 3" and has now been sealed with concrete grout.

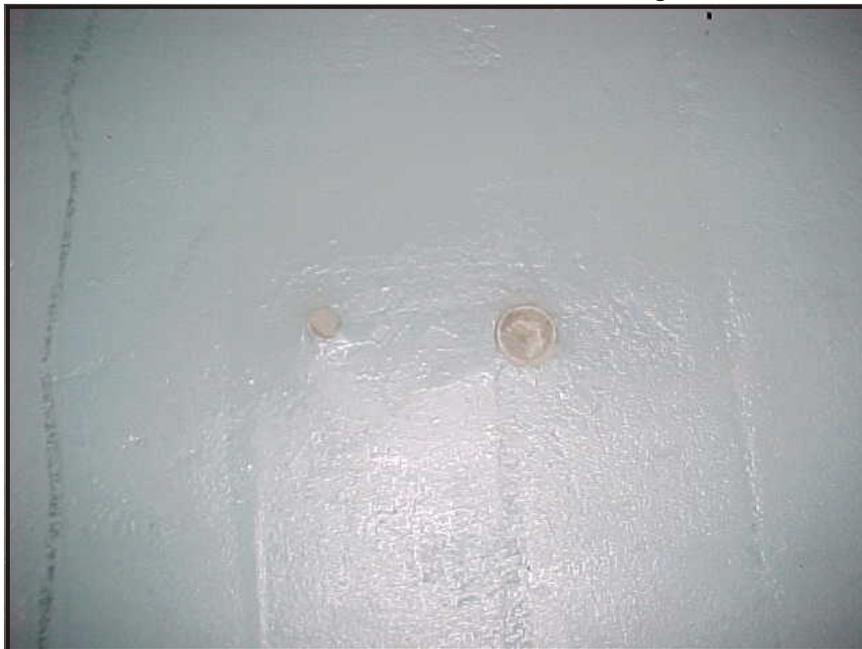
(16) Photo of two conduit openings on the west wall of the fenced in record storage area in front of the steel double door opening that have now been sealed with concrete grout.

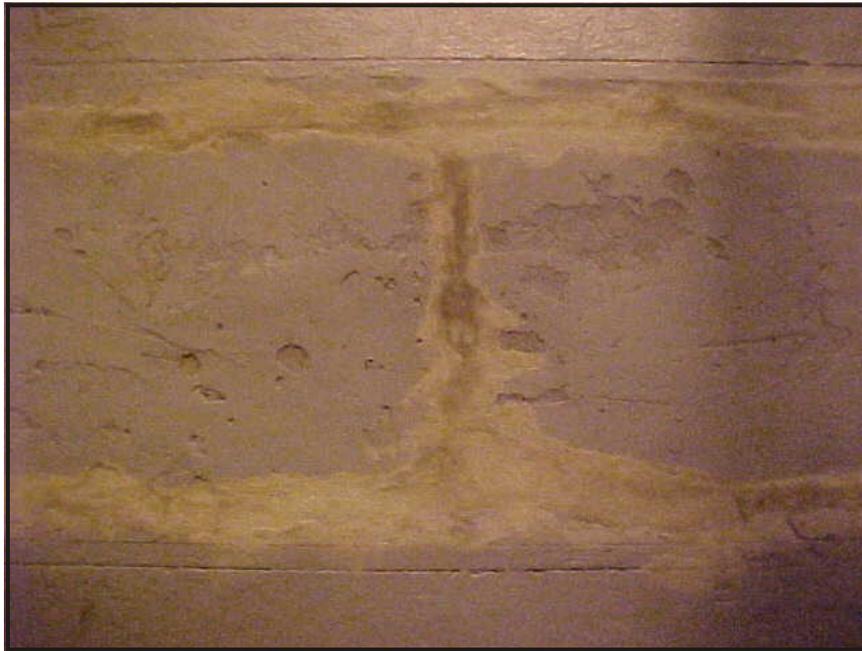
(17) Photo of a superficial crack on the east end of the fenced in records storage area in front of the double fenced gate that has now been sealed with concrete grout.

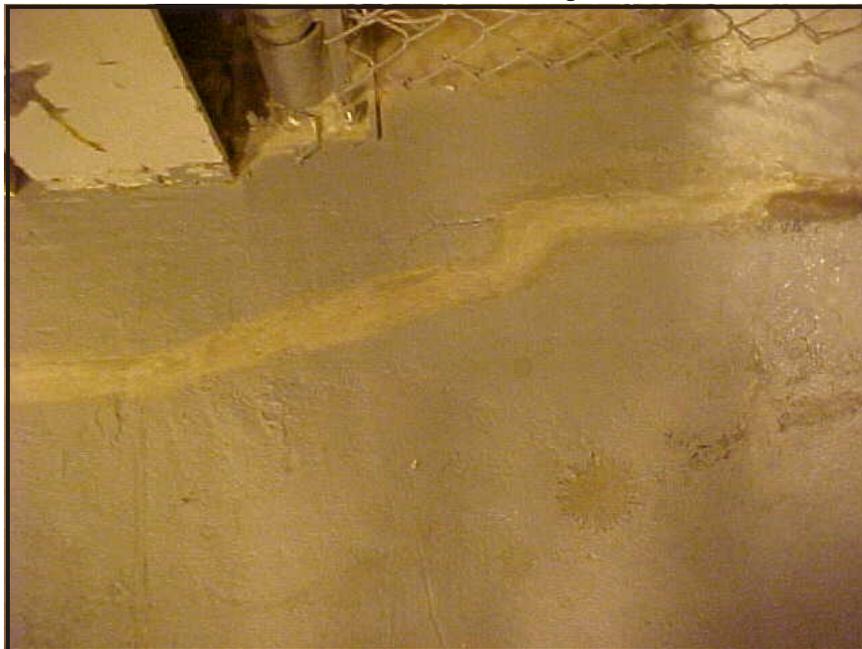
(19) Photo of a superficial crack in front of the southeast exit door of the records storage area that is not fenced in that has now been sealed with concrete grout.

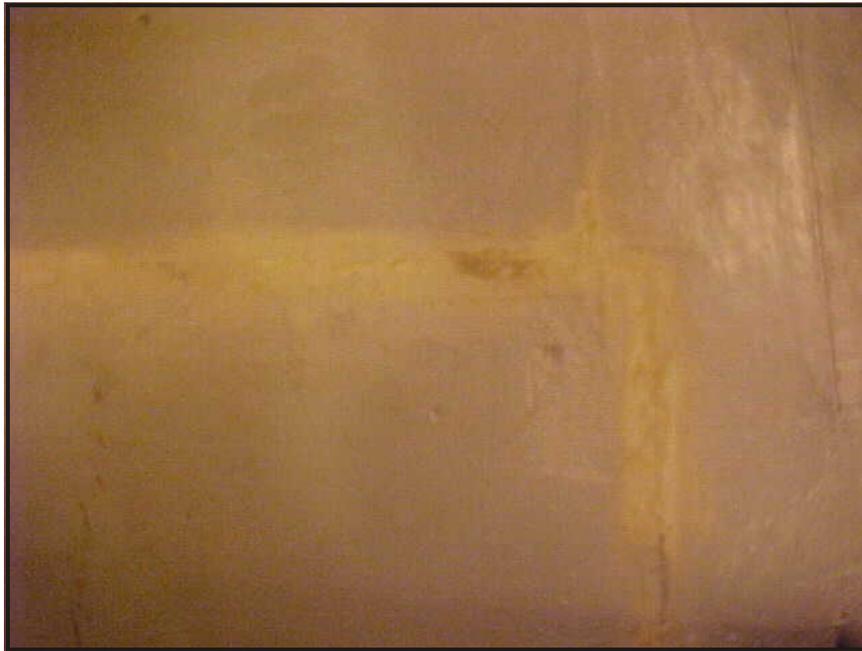
(20) Photo of a superficial crack in the concrete floor that runs from north to south in front of the mechanics crib that has now been sealed with concrete grout.

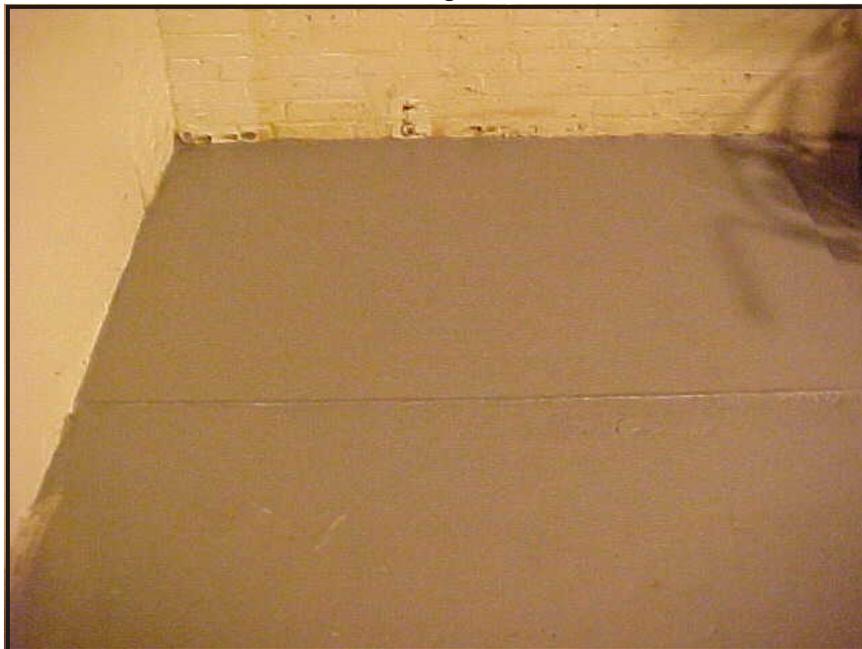
(25) Photo of previous location of steam pipes that extended through a steel grated plate in the northeast corner of the maintenance shop area. The steam pipes have now been cut below the steel grate and a new steel grate was fitted and sealed over the pit below.
